Current radioactive concentration of the seawater in Miyagi, Fukushima, Ibaraki and Chiba

Countermeasures for the contaminated ground water leakage at TEPCO's Fukushima Daiichi Nuclear Power Station

Countermeasures for contaminated water leakage from the bolted tank Att. 6

- ❑ On August 19, TEPCO found 300 m³ of highly-contaminated water leakage from a bolted joint tank in the H4 area. TEPCO has been investigating the root cause.
- ❑ TEPCO inspected all of bolt jointed tanks (305 units) on August 22 in accordance with the direction of METI. TEPCO found traces with high dose on two other tanks at near the bottom of the shell. These traces had dried up already and there was no indication that the leaked water had flowed out the dike. Also, the stored water level of each tank had been the same level as that of the beginning of storage.
- ❑ TEPCO started transfer of contaminated water from the leaking tank from August 19 and completed it on August 21.

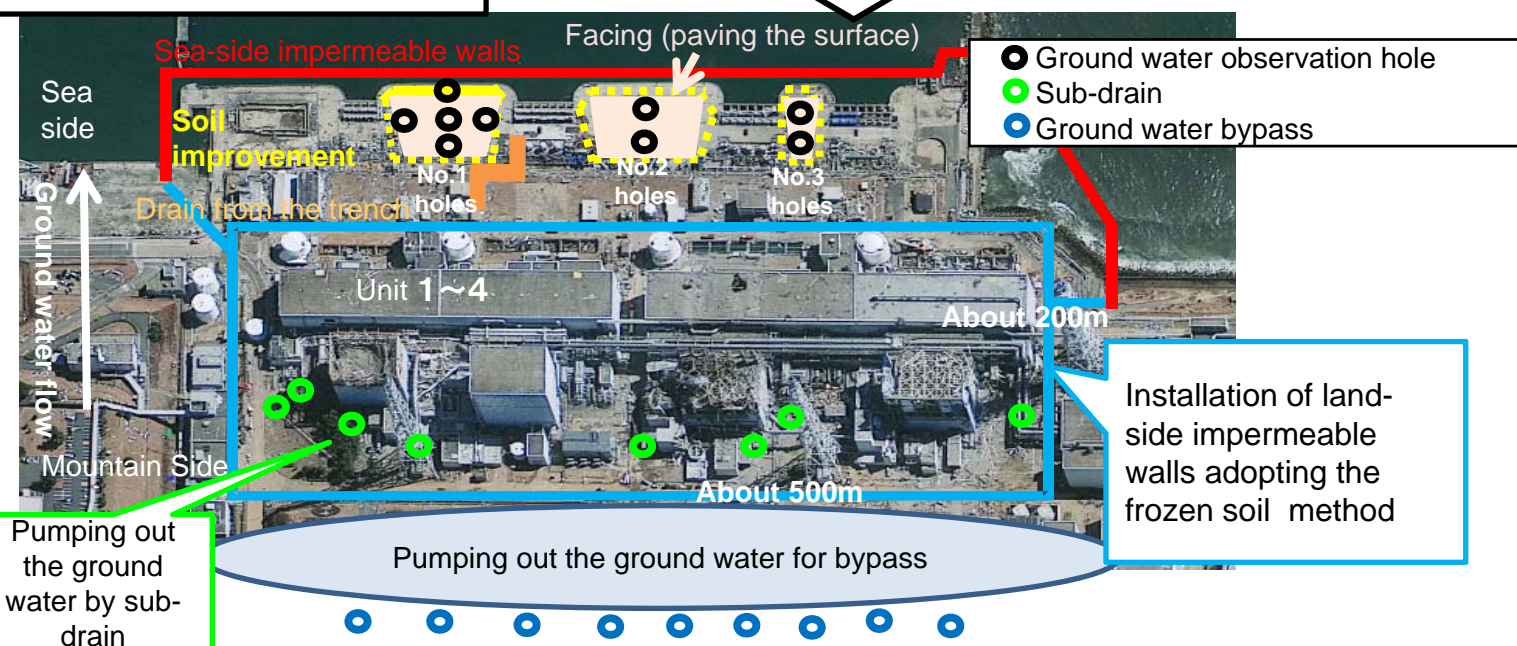
Overview of the countermeasures

- Contaminated ground water was detected in the area between the turbine buildings and plant port of the Fukushima Daiichi NPS.
- Fundamental countermeasures will be taken in several phases in addition to the immediate countermeasures.

TEPCO estimates that the whole area of units 1 to 4 has approx. 1000 m³ of ground water flow every day and 400 m³ of this flows into the basement of the facility buildings. And some part of the other water is considered to be contaminated by the water in the trench and flows into the port through the soil.

1. Removing water containing high amount of radioactive materials from the trench (underground space where the pipes and electronic cables are set) (start from August 22) **【Removing】**
2. Improving the soil by sodium silicate (liquid glass), paving the land surface with asphalt, pumping out the underground water (pumping out: start from August 9) **【Isolating】【Preventing leakage】**
3. Pumping out ground water from the mountain side (Bypassing ground water) **【Isolating】**

1. Pumping out the ground water from the sub-drains **【Isolating】**
2. Installation of sea-side impermeable walls **【Preventing leakage】**
3. Installation of land-side impermeable walls adopting the frozen soil method **【Isolating】【Preventing leakage】**
4. Installation of high performance contaminated water treatment equipment **【Removing】** etc.

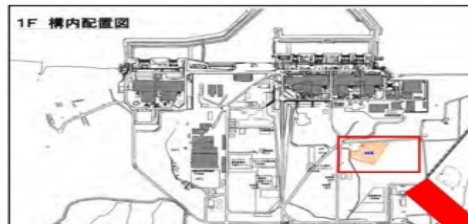
H4 area is located about 500 m away from the sea

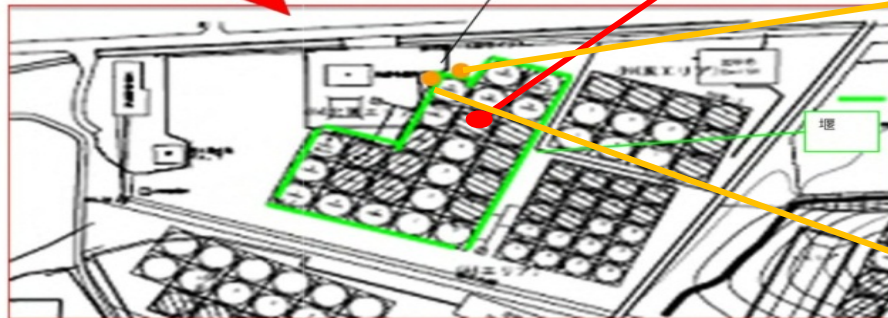
No. 5 tank

The place where paddles were found

1. **Total inspection of bolted joint tanks:**
2. **Water transfer from tanks, similar to No.5 tank, which were moved after installation :** Transfer of contaminated water from the two tanks with a similar history to H4-I-No.5 tank had started. One of them completed on August 27.

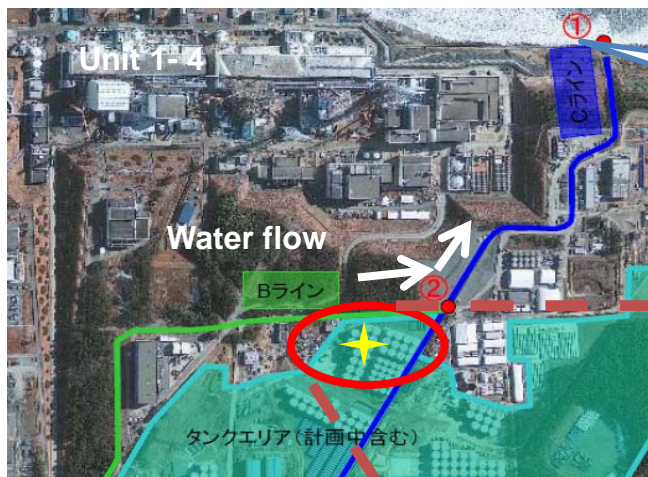
Radiation dose at the surrounding area of the tank

Total beta and cesium concentration at outlet of the dike was under detection limit (sampled on August 26)

5.8 mSv was detected at the dike (on August 21)

3. **Contaminated soil collection :** Start from August 23. It is under examination for the early completion.
4. **Inspection and reinforcement of the surrounding dikes:** The dikes around the tanks were confirmed not to be contaminated on August 22. Land embankments and waterproof sheets have been added to the sandbags outside the H4 area where the leakage occurred.

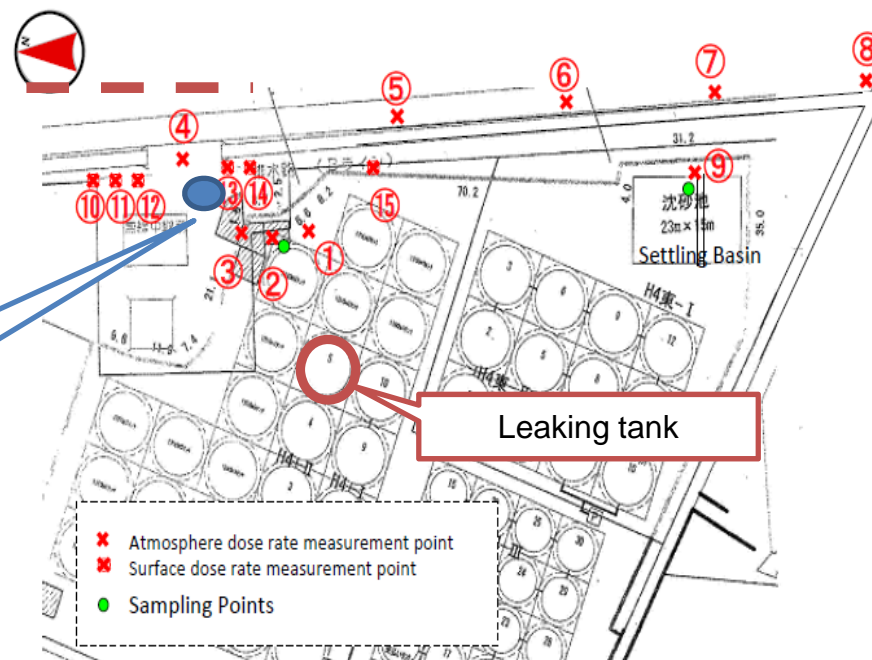
Dose Rate

Date: Aug. 19, 2013
Unit: [mSv/h]
